Project Church of St Luke Sedgefield

Title Elevations- proposed

Dwg. No. SP-384/A-PL-13 /F

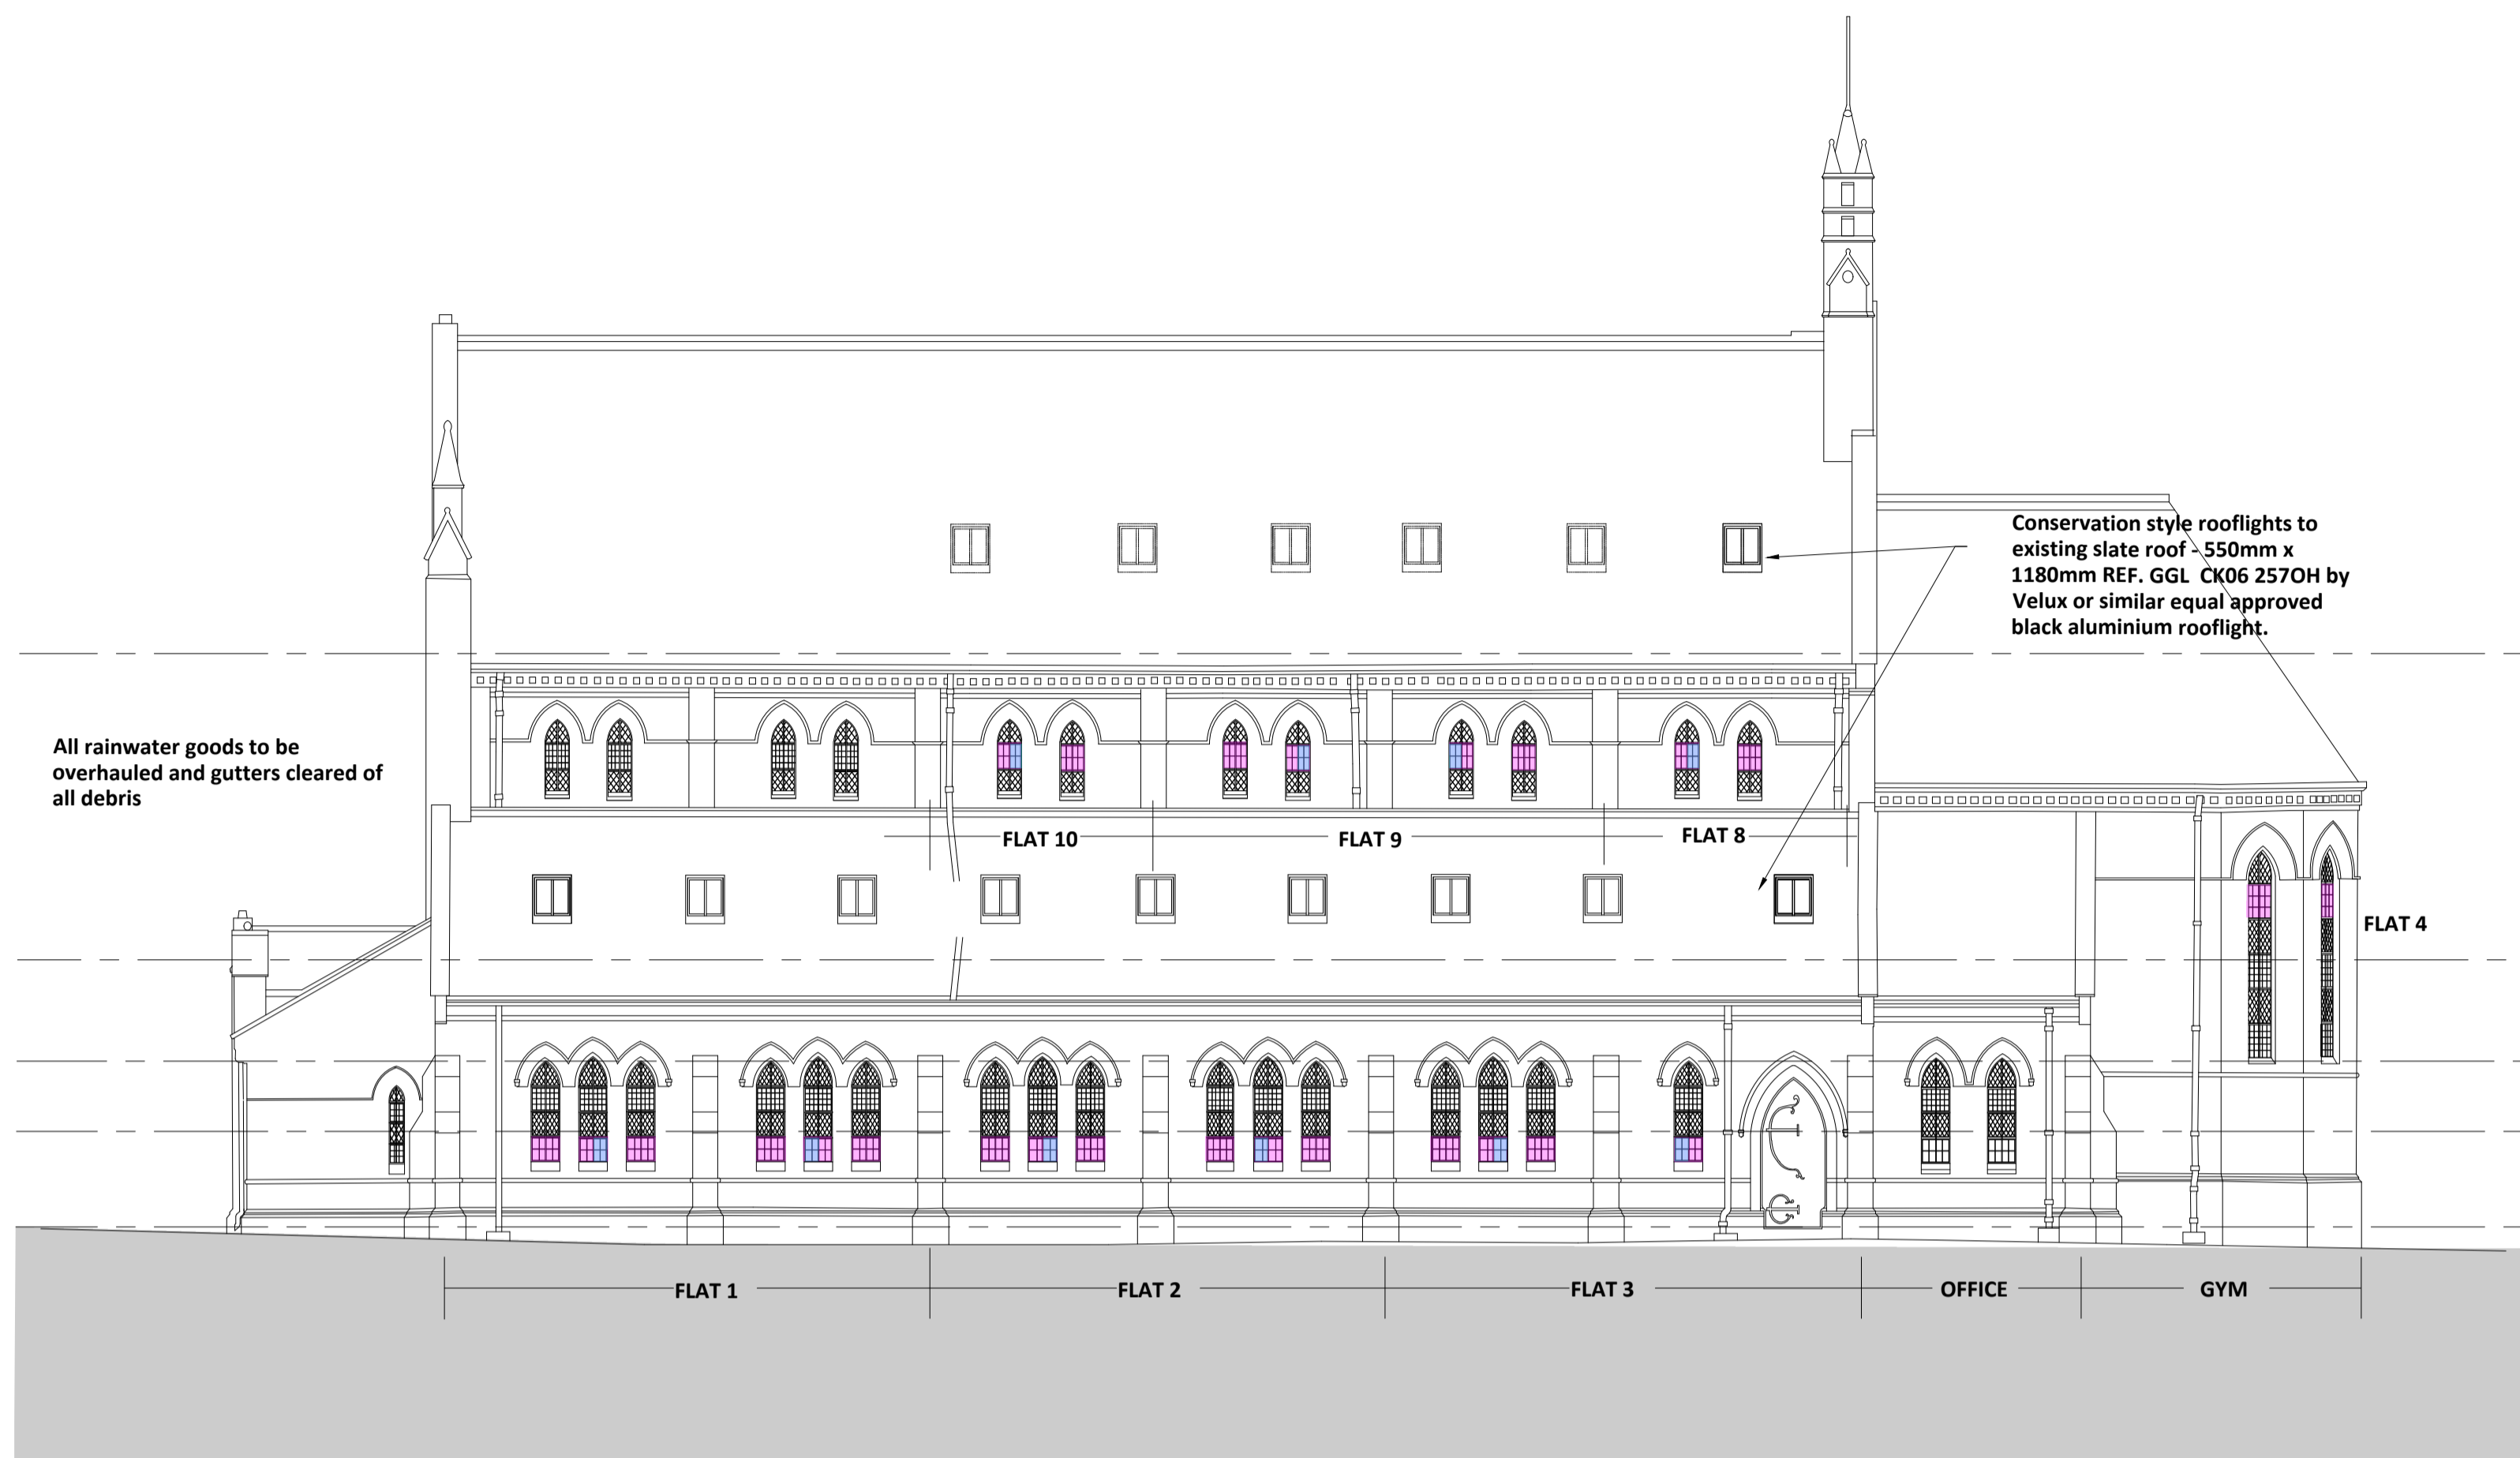
NORTH ELEVATION

- WINDOWS TO BE REPLACED WITH CLEAR GLASS AS DETAIL ON DRAWING 15
- WINDOW HOPPER OPENING LIGHT TO BE PROVIDED-refer to dwg. no. 15 for details

All windows not shaded to have localised repairs only retaining existing frames and glass where possible. Many of the windows have been subject to vandalism, particularly at ground floor (though not limited to this) with both the lattice leaded glazing and frames damaged to many windows. A quotation to carry out the repairs and restorative works has been prepared by The Stained Glass Shop, Middlesbrough. Works to consist of:
 Repair stained glass windows across every window in the church.
 93 sections of glass to be repaired or replaced with clear leaded glass
 18 stainless steel openers
 104 glass insitu repairs

All work to be traditional stained-glass method every section is individual. Glass to match the original and where possible one set of windows will have new glass and salvaged glass to be used in repairs. Metal frames to be drop open onto stays.
