## Single Survey

**31 Breadalbane Terrace  
Wick  
Caithness  
KW1 5AG**

survey report on :

<b>Customer</b>	Mr Grant Wydmuch
<b>Customer Address</b>	31 Breadalbane Terrace Wick Caithness KW1 5AG
<b>Date of Inspection</b>	16 <sup>th</sup> January 2017
<b>Prepared by</b>	Keith Bowman BSc MRICS Registered Valuer

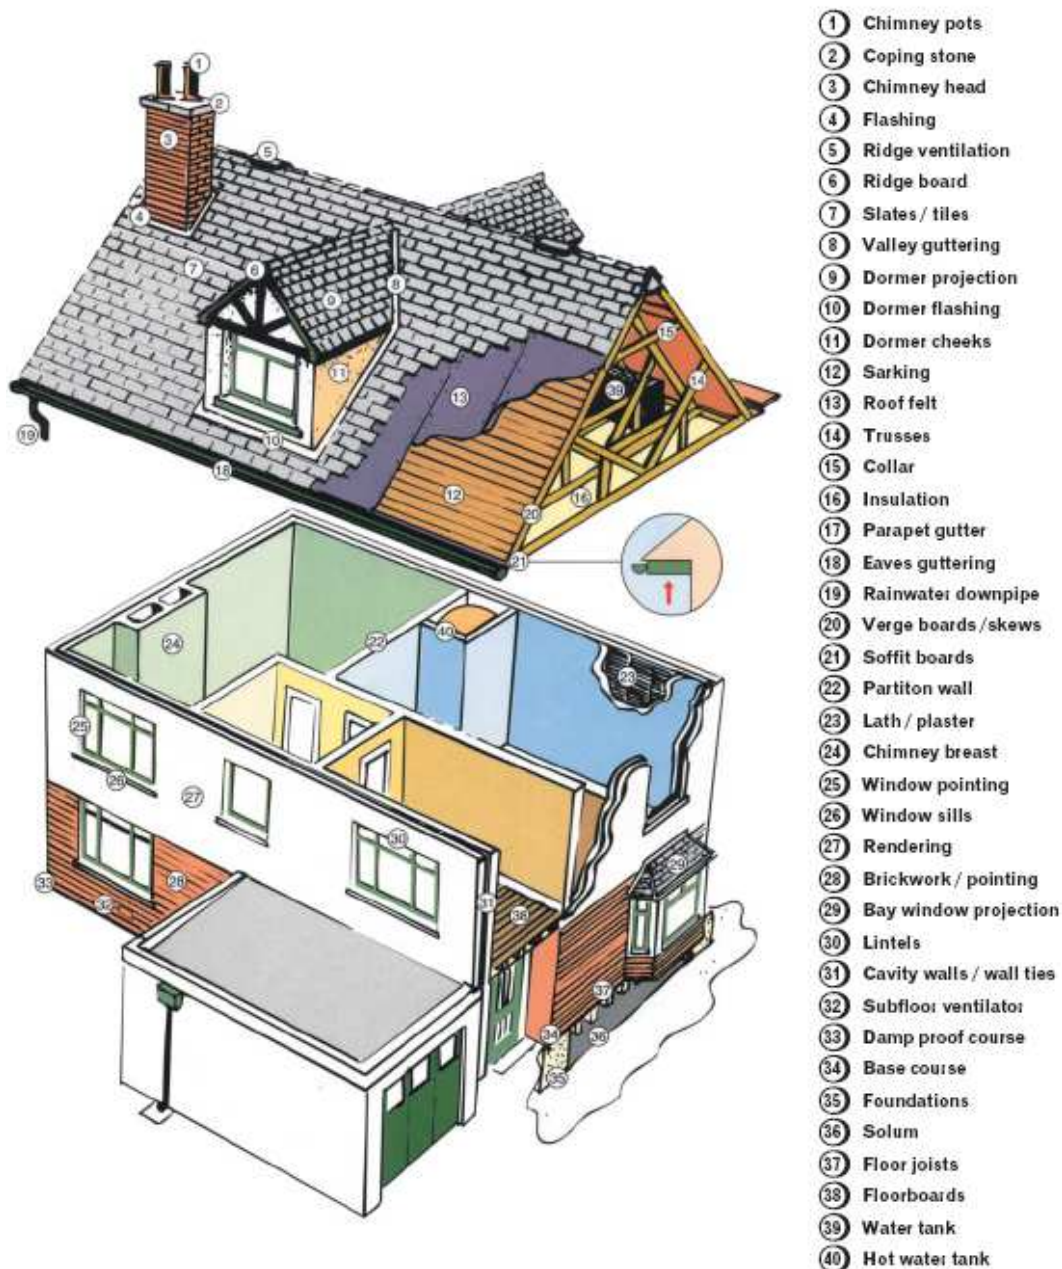
### Sectional Diagram showing elements of a typical house

Reference may be made in this report to some or all of the above component parts of the property. This diagram may assist you in locating and understanding these items.

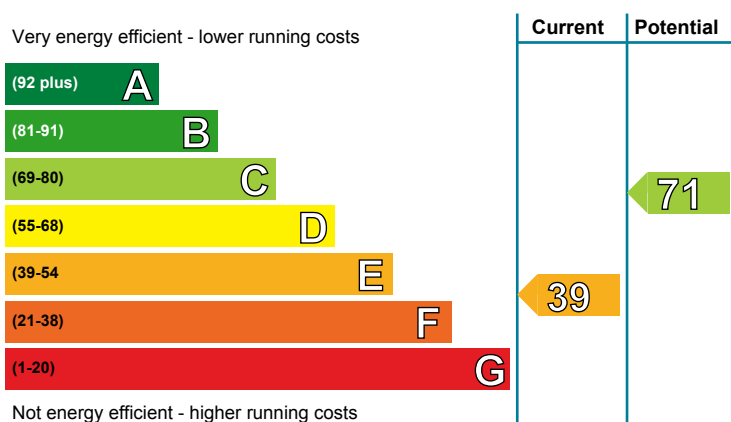
## Energy Efficiency Rating

This graph shows the current efficiency of your home, taking into account both energy efficiency and fuel costs. The higher this rating, the lower your fuel bills are likely to be.

Your current rating is **band E (39)**. The average rating for EPCs in Scotland is **band D (61)**.

The potential rating shows the effect of undertaking all of the improvement measures listed within your recommendations report.

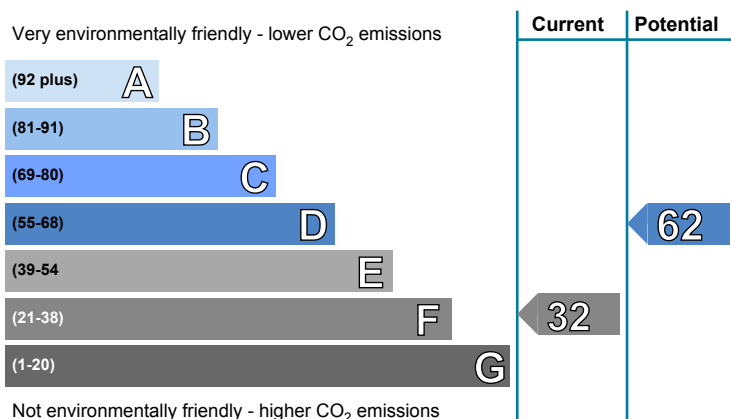
## Environmental Impact (CO<sub>2</sub>) Rating

This graph shows the effect of your home on the environment in terms of carbon dioxide (CO<sub>2</sub>) emissions. The higher the rating, the less impact it has on the environment.
