**SK6.1B**

Boultons Old Offices  
Ground Floor As Proposed  
Scale 1:100 Dwg. No.

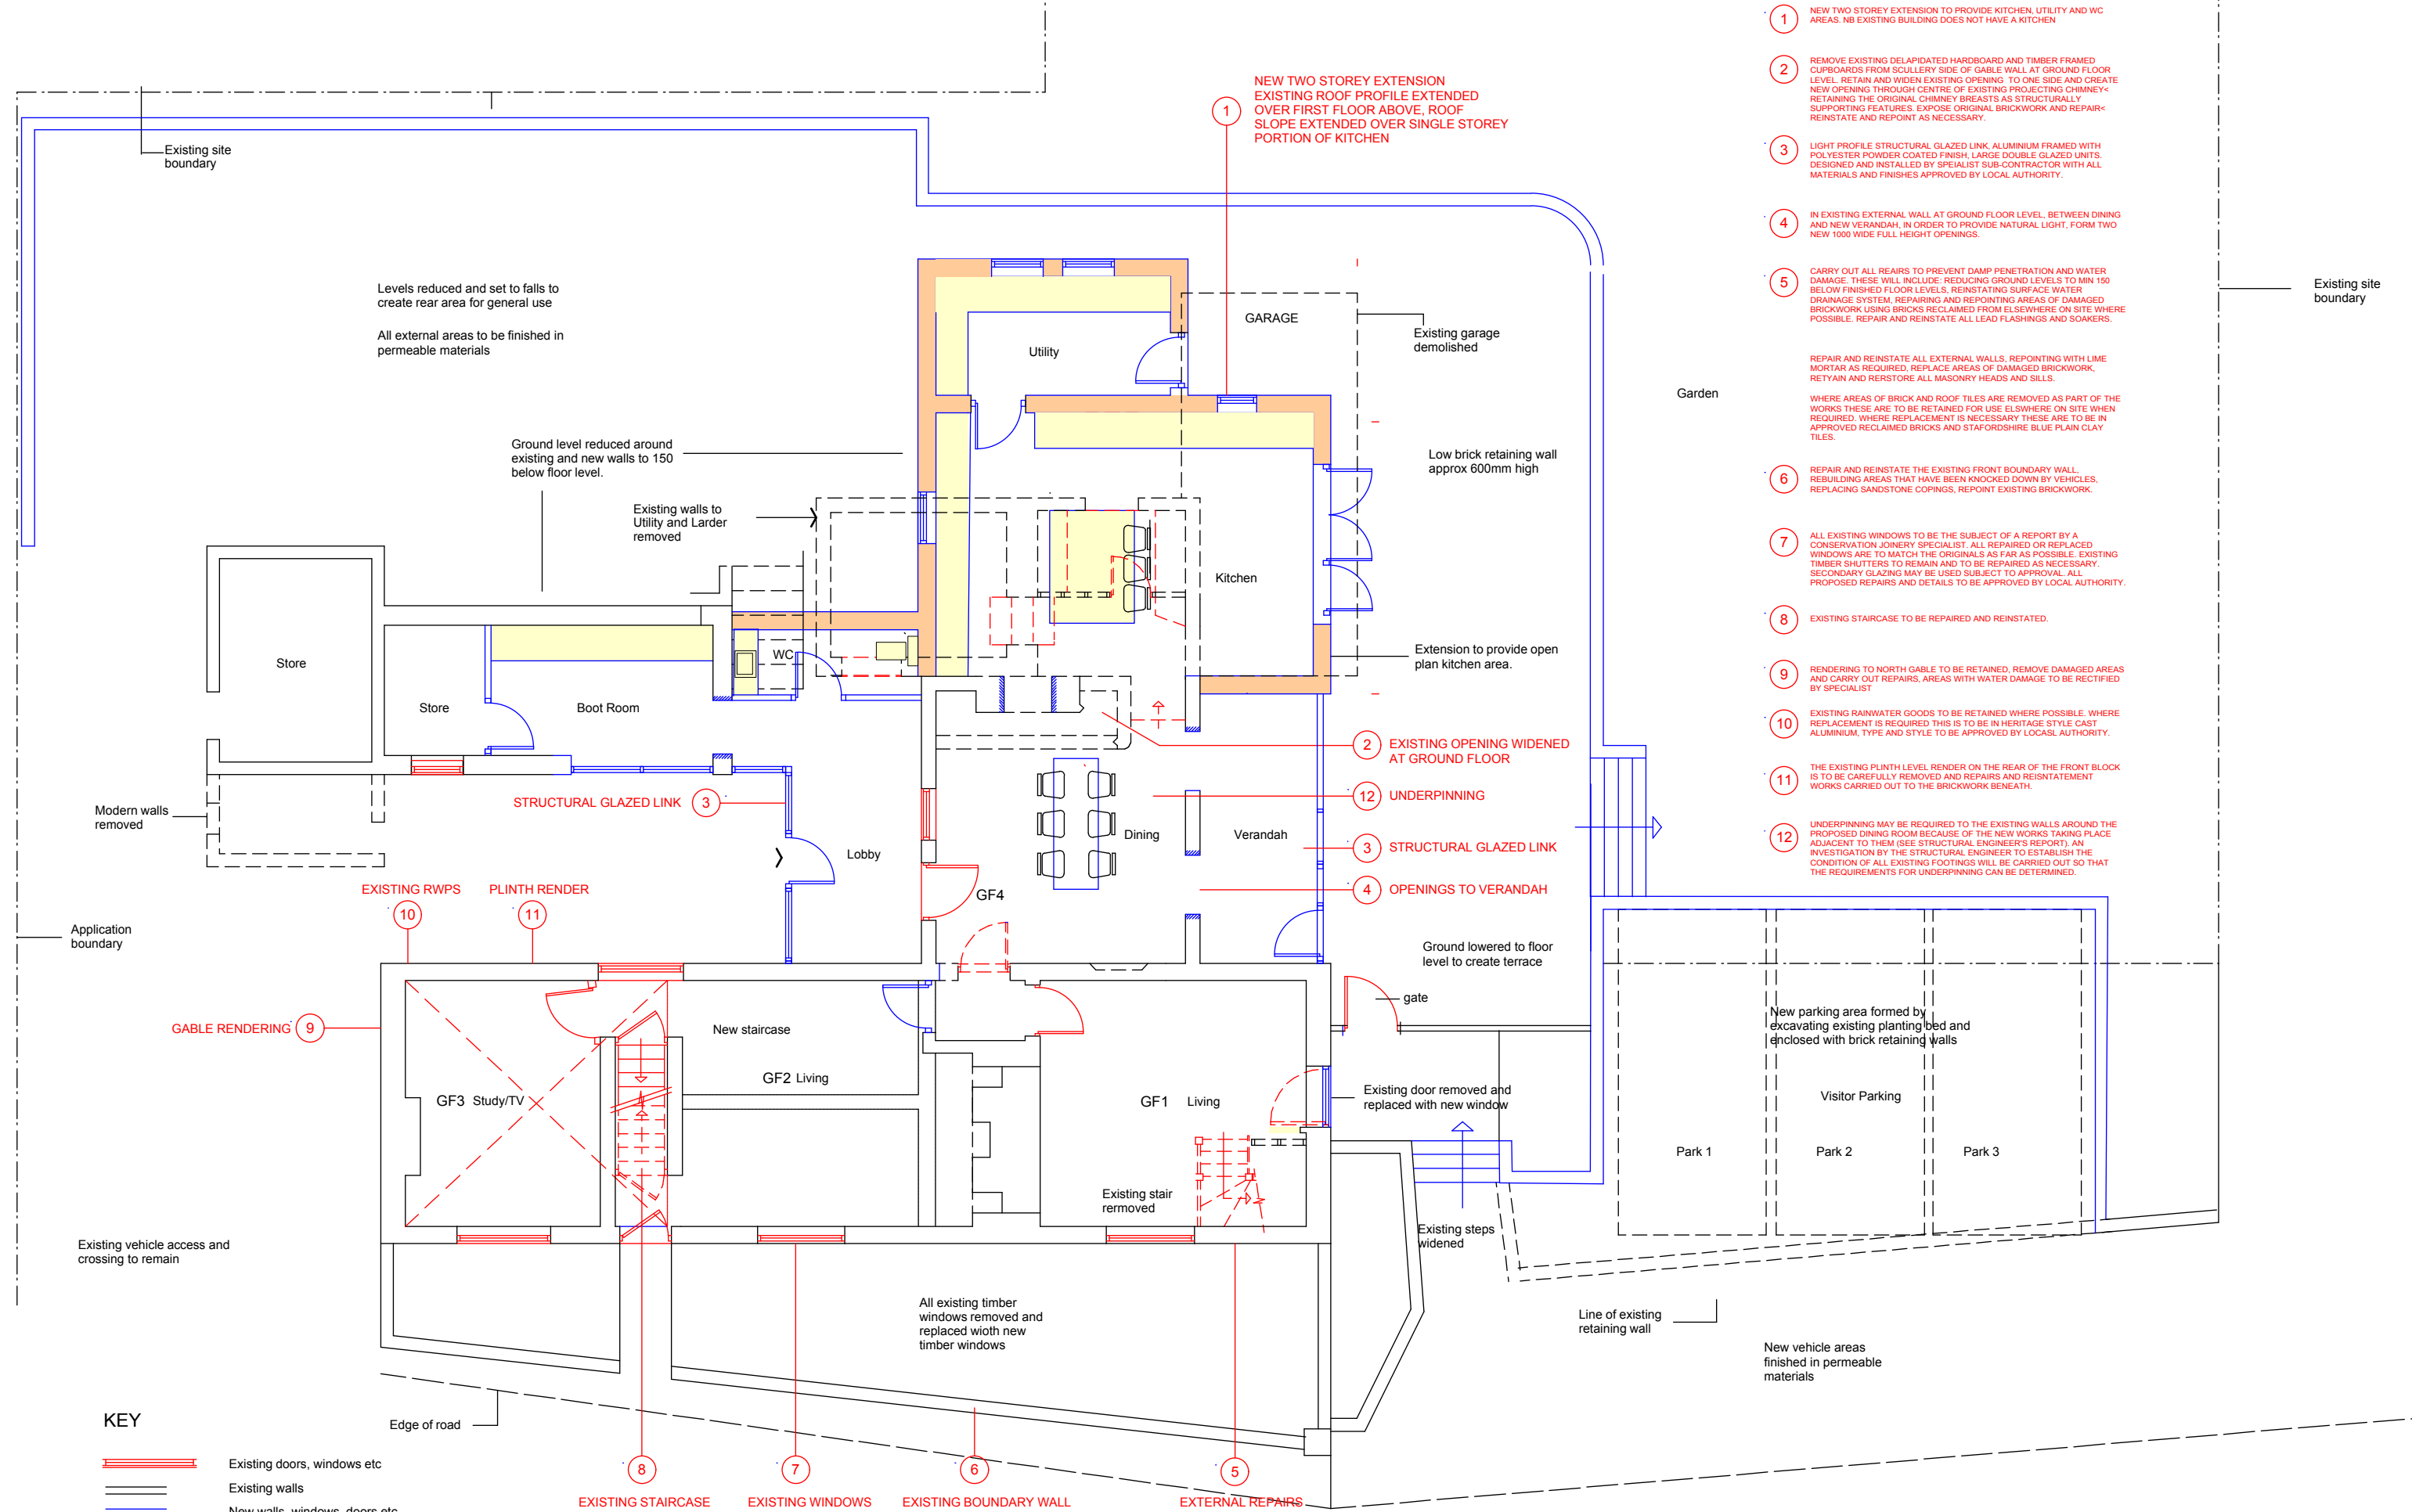
- 1 NEW TWO STOREY EXTENSION TO PROVIDE KITCHEN, UTILITY AND WC AREAS. NB EXISTING BUILDING DOES NOT HAVE A KITCHEN
- 2 REMOVE EXISTING DELAPIDATED HARDBOARD AND TIMBER FRAMED CUPBOARDS FROM SCULLERY SIDE OF GABLE WALL AT GROUND FLOOR LEVEL. RETAIN AND WIDEN EXISTING OPENING TO ONE SIDE AND CREATE NEW OPENING THROUGH CENTRE OF EXISTING PROJECTING CHIMNEY< RETAINING THE ORIGINAL CHIMNEY BREASTS AS STRUCTURALLY SUPPORTING FEATURES. EXPOSE ORIGINAL BRICKWORK AND REPAIR< REINSTATE AND REPOINT AS NECESSARY.

- 3 LIGHT PROFILE STRUCTURAL GLAZED LINK. ALUMINIUM FRAMED WITH POLYESTER POWDER COATED FINISH. LARGE DOUBLE GLAZED UNITS. DESIGNED AND INSTALLED BY SPECIALIST SUB-CONTRACTOR WITH ALL MATERIALS AND FINISHES APPROVED BY LOCAL AUTHORITY.

- 4 IN EXISTING EXTERNAL WALL AT GROUND FLOOR LEVEL, BETWEEN DINING AND NEW VERANDAH, IN ORDER TO PROVIDE NATURAL LIGHT, FORM TWO NEW 1000 WIDE FULL HEIGHT OPENINGS.

- 5 CARRY OUT ALL REPAIRS TO PREVENT DAMP PENETRATION AND WATER DAMAGE. THESE WILL INCLUDE: REDUCING GROUND LEVELS TO MIN 150 BELOW FINISHED FLOOR LEVELS, REINSTATING SURFACE WATER DRAINAGE SYSTEM, REPAIRING AND REPOINTING AREAS OF DAMAGED BRICKWORK USING BRICKS RECLAIMED FROM ELSEWHERE ON SITE WHERE POSSIBLE. REPAIR AND REINSTATE ALL LEAD FLASHINGS AND SOKERS.

- REPAIR AND REINSTATE ALL EXTERNAL WALLS. REPOINTING WITH LIME MORTAR AS REQUIRED, REPLACE AREAS OF DAMAGED BRICKWORK. RETAIN AND RESTORE ALL MASONRY HEADS AND SILLS.

- WHERE AREAS OF BRICK AND ROOF TILES ARE REMOVED AS PART OF THE WORKS THESE ARE TO BE RETAINED FOR USE ELSEWHERE ON SITE WHEN REQUIRED. WHERE REPLACEMENT IS NECESSARY THESE ARE TO BE IN APPROVED RECLAIMED BRICKS AND STAFFORDSHIRE BLUE PLAIN CLAY TILES.

- 6 REPAIR AND REINSTATE THE EXISTING FRONT BOUNDARY WALL. REBUILDING AREAS THAT HAVE BEEN KNOCKED DOWN BY VEHICLES. REPLACING SANDSTONE COPINGS. REPOINT EXISTING BRICKWORK.

- 7 ALL EXISTING WINDOWS TO BE THE SUBJECT OF A REPORT BY A CONSERVATION JOINERY SPECIALIST. ALL REPAIRED OR REPLACED WINDOWS ARE TO MATCH THE ORIGINALS AS FAR AS POSSIBLE. EXISTING TIMBER SHUTTERS TO REMAIN AND TO BE REPAIRED AS NECESSARY. SECONDARY GLAZING MAY BE USED SUBJECT TO APPROVAL. ALL PROPOSED REPAIRS AND DETAILS TO BE APPROVED BY LOCAL AUTHORITY.

- 8 EXISTING STAIRCASE TO BE REPAIRED AND REINSTATED.
- 9 RENDERING TO NORTH GABLE TO BE RETAINED. REMOVE DAMAGED AREAS AND CARRY OUT REPAIRS. AREAS WITH WATER DAMAGE TO BE RECTIFIED BY SPECIALIST

- 10 EXISTING RAINWATER GOODS TO BE RETAINED WHERE POSSIBLE. WHERE REPLACEMENT IS REQUIRED THIS IS TO BE IN HERITAGE STYLE CAST ALUMINIUM. TYPE AND STYLE TO BE APPROVED BY LOCAL AUTHORITY.

- 11 THE EXISTING PLINTH LEVEL RENDER ON THE REAR OF THE FRONT BLOCK IS TO BE CAREFULLY REMOVED AND REPAIRS AND REINSTATEMENT WORKS CARRIED OUT TO THE BRICKWORK BENEATH.

- 12 UNDERPINNING MAY BE REQUIRED TO THE EXISTING WALLS AROUND THE PROPOSED DINING ROOM BECAUSE OF THE NEW WORKS TAKING PLACE ADJACENT TO THEM (SEE STRUCTURAL ENGINEER'S REPORT). AN INVESTIGATION BY THE STRUCTURAL ENGINEER TO ESTABLISH THE CONDITION OF ALL EXISTING FOOTINGS WILL BE CARRIED OUT SO THAT THE REQUIREMENTS FOR UNDERPINNING CAN BE DETERMINED.
